## Case Study: Hemel Hempstead, England (December, 2005)

In the following example, an ineffective instrumentation maintenance and repair program combined with undermanaged instrument change and other automation deficiencies, leading to a vapor cloud explosion.

Impact: Explosion and fire; 43 injuries; 2,000 evacuated, commercial and residential damage

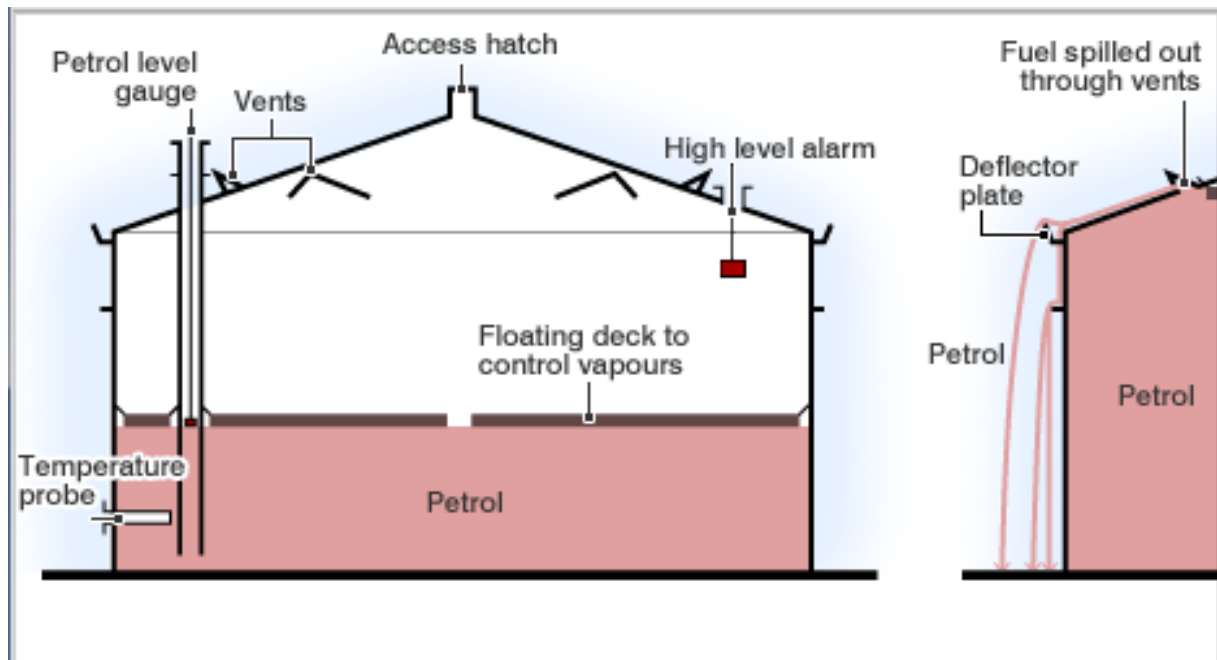
### Vessel Diagram:

Gasoline was being delivered to Tank 912, starting on the day before the incident. Early the next morning, the Automatic Tank Gauging (ATG) system displayed an unchanging level in Tank 912, although the tank continued to fill. A 'flat-lined' signal, where the sensor or transmitter output is stuck and the signal it sends to the control system is no longer related to the process condition, is a known dangerous failure mode for the level gauge technology used in this vessel. This type of failure can be difficult to detect by operators,

because the output is still within the acceptable range for the process variable. A review of the instrumentation data revealed that the level gauge in this tank had 'flat-lined' 14 times in the 3.5 months leading up to this incident, but this frequent malfunction was not recognized as being an abnormal situation and so was not escalated to senior supervision for resolution prior to the incident.

The 'user', 'high', and 'high high' level alarms used the same tank level transmitter, so the failure of the shared transmitter rendered these alarms inoperative. By practice, the operator controlled level by terminating transfer upon receipt of the 'user' alarm. Since it was not available, the operator did not take action to terminate transfer.

An independent high-level switch, set above the ATG high-high level, was designed to close inlet valves and activate an audible alarm, but it also failed. Eighteen months prior to the incident, the high level switch had been changed out for a different technology which the instrument maintenance team did not fully understand. The high level switch became disabled when maintenance, not understanding the full outcome of their decision, failed to reinstall a lock on the switch test arm after performing work. Without the lock, the level switch was not activated when the float was lifted. This systematic failure demonstrates the importance of ensuring that maintenance and repair procedures, labeling, and training be used to sustain integrity.

By late afternoon, the tank overfilled and contents spilled out of tank roof vents. A vapor cloud was formed and noticed by tanker drivers and by people outside the facility. The fire alarm was activated and firewater pumps were started. An explosion occurred a short time later, likely ignited by the startup of the firewater pumps.

- Inadequate / no risk assessment
- Analog level gauge not maintained, 14 dangerous failures (stuck) in preceding 3.5 months
- Analog level gauge criticality not recognized, safety implications of frequent dangerous failures not noted or logged.
- Analog failure unnoticed, lead to ATG system malfunction / 'flatline'
- 3 alarms failed to activate as a result of analog level failure
- Level switch technology changed without adequate change management
- Incorrect level switch installation
- Separate high level interlocks failed
- Inadequate ATG HMI
- No measurement validation / deviation alarm
- ESD shown on HMI but never implemented

The test facility disabled the high level detection when a padlock was not replaced on the test arm. The manufacturer manual contained a warning that the padlock needed to be in place. It is critical to train maintenance staff on how to properly test new or modified equipment and how to verify that the equipment has been properly returned to service. Labeling and warning signs should be considered to enhance recognition of critical features and configuration.

In addition, instrument repair procedures should include a check for unacceptably high failure rates. For example, the analog level gauge in this case had failed many times in the few months preceding the event. Written instructions should be provided on how to escalate these situations to maintenance and facility leadership for investigation and correction.
