Case Study: Ontario, California (August, 2004)

In the following example, insufficient training on bypassing the safeguards on a medical materials sterilization chamber led to an explosion.

Impact: Explosion; 4 injuries; community evacuated; facility damaged.

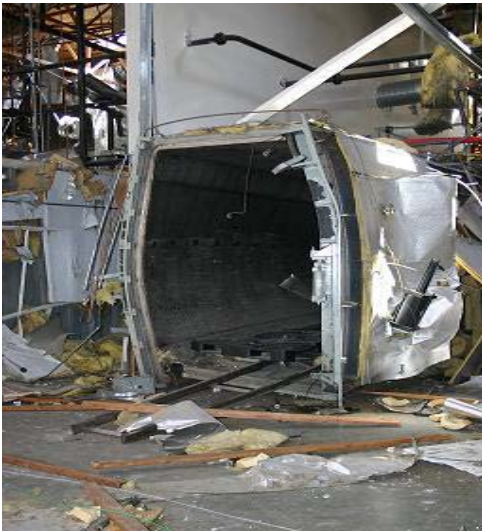
Sterilization chamber after explosion

Minutes after the bypass, the chamber door was cracked opened. This automatically activated the ventilation duct, designed to sweep residual EO from the sterilization chamber to an oxidizer. Because the gas washes were omitted, about 50 pounds of EO entered the ventilation system, igniting as it reached the oxidizer. Area monitors activated as EO leaked from the chamber, but time was insufficient to trip the oxidizer or evacuate before the vapor cloud ignited. The flame travelled back through the chamber to ignite the remaining EO, causing a massive explosion that sent both chamber doors flying outward. Injuries to four individuals in the control room overlooking the sterilization chamber area occurred as a result of overpressure shattering the windows.

All personnel involved in the lifecycle of instrumented safeguards should be trained on the design intent of each task expected from them. This training should address predicted abnormal operating modes as well as routine operation. In this case study, both operators and the maintenance supervisor given the responsibility of authorizing the use of safeguard bypasses by maintenance technicians should have been trained that the washes were always required to purge the highly explosive material from the chamber, whether the chamber was empty of product or not. Periodic competency assessments should be used to ensure that training was effective and the skills have been retained over time. Written operator procedures should also clearly describe the function of the safety systems and the hazards that they are designed to prevent. Bypass procedures should include the compensating measures that must be used to manage risk when a particular safety function is to be bypassed. Finally, recognized and generally accepted good engineering practices should always be applied to occupied building design, even if instrumented safeguards have been installed to manage process risk.

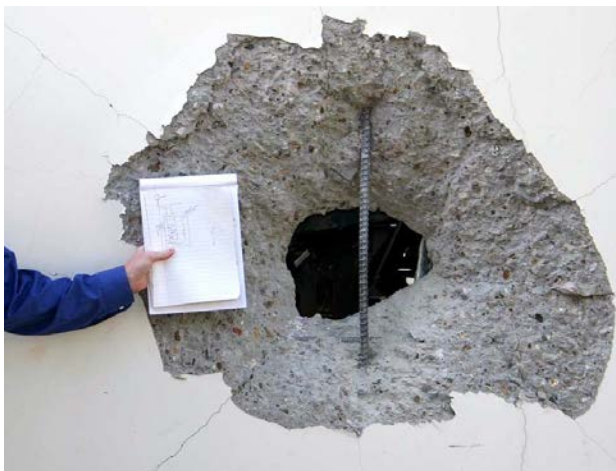
CSB Report Figure 12

Photograph of building damage from chamber door
