Case Study: Petrolia, Pennsylvania (October, 2008)

In the following example, inadequate management of a "temporary" automation change leads to a toxic gas release with community-wide impact.

Impact: Oleum release; 1 injured, plant and 2500 in local towns evacuated; roads closed.

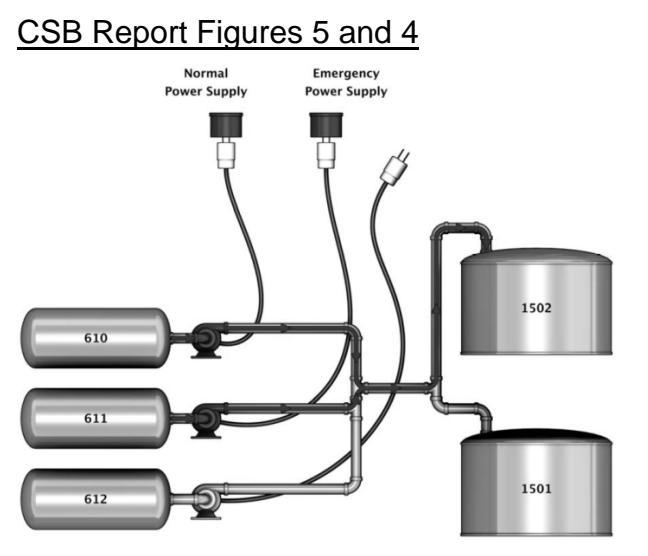
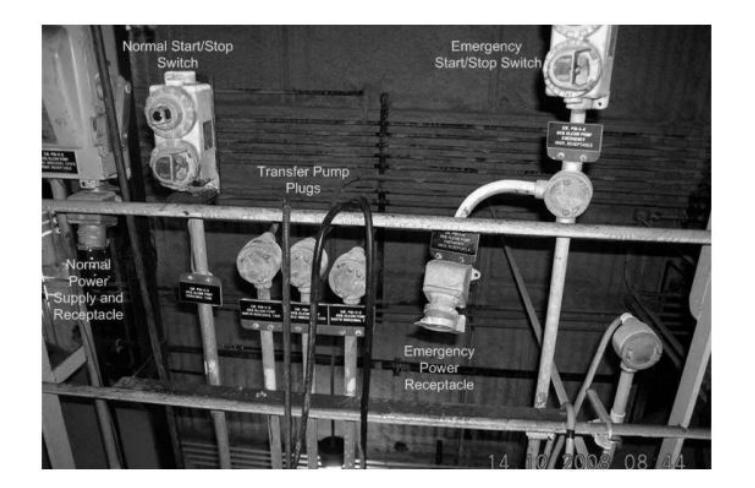
Power Configuration Diagram

- On the day of the incident, an operator was pumping oleum from vessel 611 using the primary power source and from vessel 612 using the backup power source. Status of the pump using backup power was not indicated on the DCS, and the pump could only be stopped locally while on backup power.

- When the operator stopped pumping from vessel 611 via the DCS at end of the weekend shift, he inadvertently left the pump on backup power running.
- When the feed tank eventually became full, a local high level alarm beacon activated on run tank 1502, but the operator had already left the control building.

- Second "temporary" power supply added 28 years prior to event, with decision to not use the same automated interlocks used on the primary supply and to rely only on operator response to alarm as a safeguard against overfill
- Change not incorporated into plant documentation or logic solver operator displays.
- Operator practice evolved to use the "temporary" power supply to run a second pump on weekends, without the close monitoring initially intended at the time of the installation of the "temporary" power supply
- Result was that high high tank level trip was effectively bypassed for the pump run on backup power
- High level alarm used as normal fill level; horn not working and no one present

Forces, jumpers, and temporary fixes can unintentionally become permanent if MOC is not robustly followed and key plant documentation is not updated. Hazard analysis and safeguard implementation are just as important for a facility change intended to be relatively short term as for a significant capital project. In this incident a "temporary" automation change became a 28-year undocumented latent failure.
