## Case Study: Illiopolis, Illinois (April, 2004)

In the following example, the use of a safety system final element bypass feature without adequate access restriction leads to a release with fatal consequences.

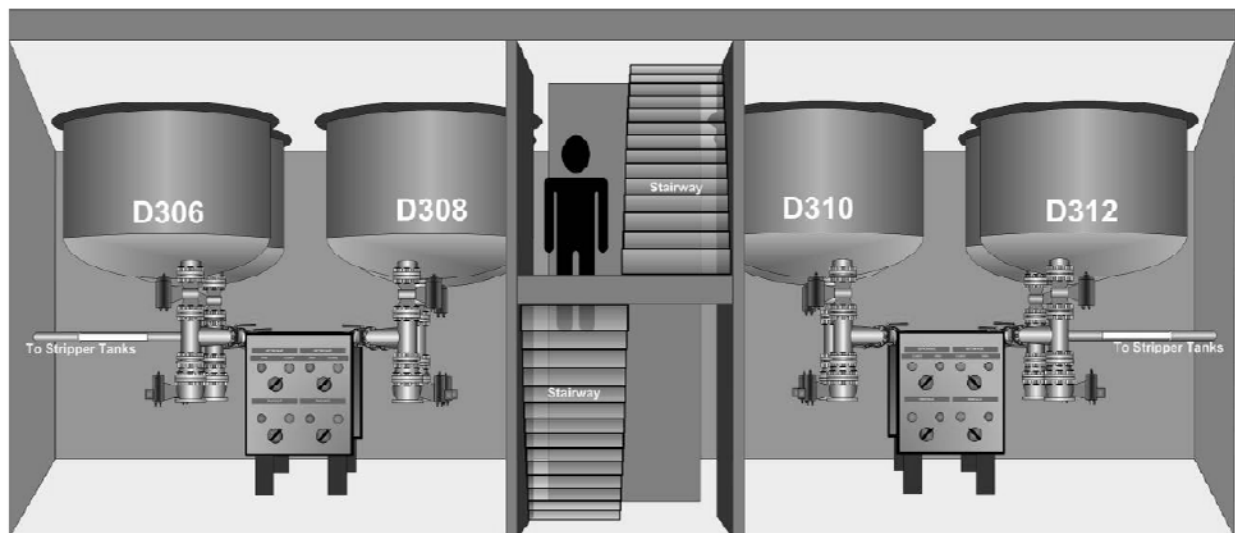
#### CSB Report Figure 7

### Cutaway of reactor building

On the night of the accident, all polyvinyl chloride (PVC) reactors were making PVC except reactor D306, which was being cleaned. After washing the reactor from the upper level, the operator went downstairs to drain out the contents of D306. Turning the wrong way coming down the stairs, the operator went to the bottom valve of reactor D310 by mistake and tried to open the bottom valve to empty the vessel.

The reactor pressure safety interlock prevented the reactor bottom valve from opening. The operator, presumably under the belief that he was still on D306 and that the interlock was therefore in error, connected an emergency bypass air hose to the actuator to force the interlocked valve open. He did not request permission to do the bypass or inform anyone of the

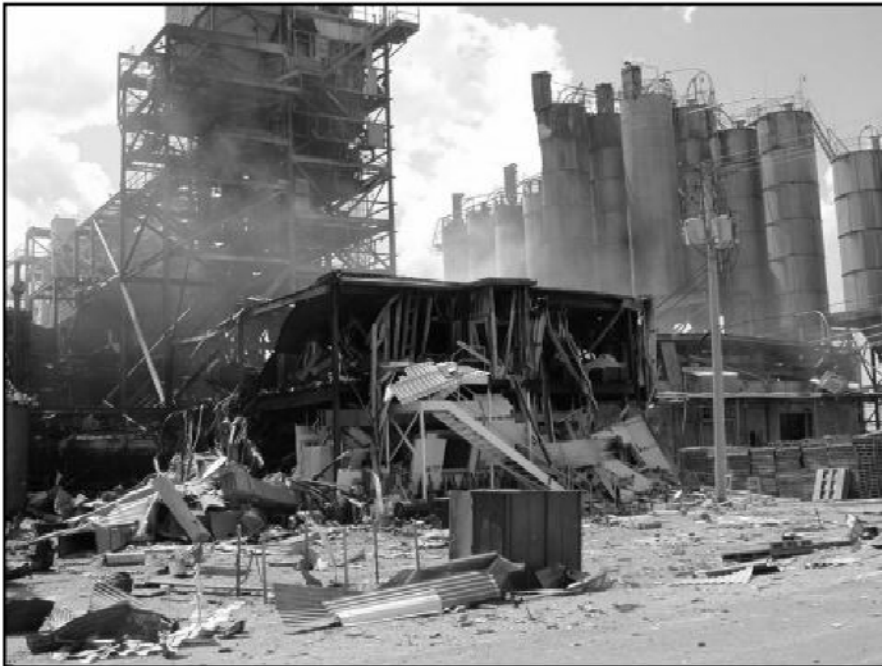
Impact: Explosion; 5 fatalities, 3 hospitalized, and 4 minor injuries; plant damaged, laboratory, safety, and engineering buildings destroyed; 150 evacuated; roads closed.

### Photograph of facility damage from the explosion CSB Report Cover

The reactor contents rapidly emptied through the bottom valve, forming a vapor cloud. Although area release monitor alarms activated and most personnel evacuated, some operators remained at the equipment in an attempt to mitigate the situation. They were still present when the vapor cloud ignited.
